Assessment of Dam Safety of Coal Combustion Surface Impoundments

Indianapolis Power & Light Company

Harding Street Generating Station

November 15, 2010

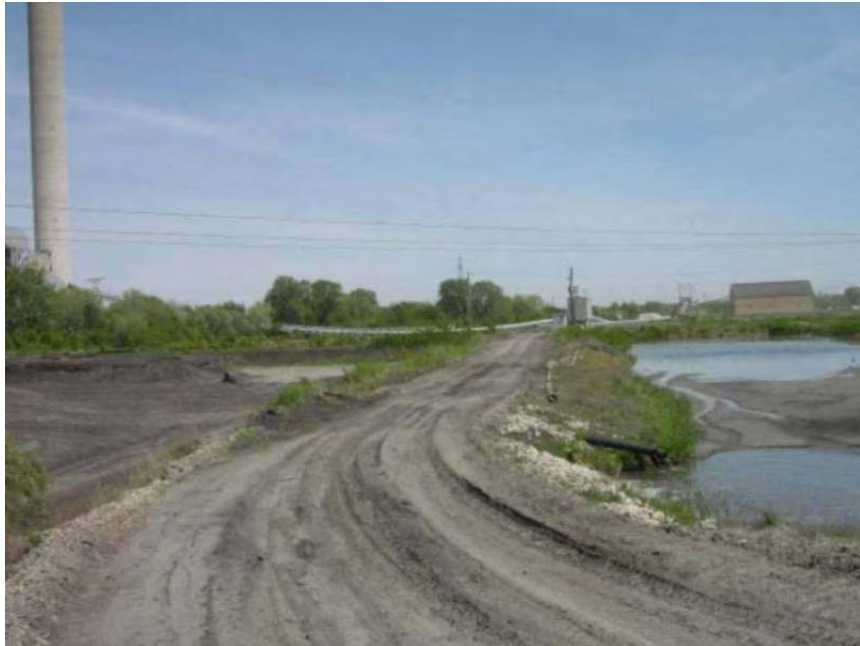
The crest of Ash Pond 1 appeared to be in satisfactory condition (Photographs 1, 8, 11, and 12). The crest was approximately 15 feet wide with the exception of the haul road portion of the crest on the north embankment that was approximately 20 feet wide. The entire crest is exposed to vehicle traffic. Depressions and minor ruts, apparently due to vehicle traffic, were observed on the crest of each embankment (Photograph 1, 8 and 12). The crest surface appears to consist of compacted granular soils. A section of the crest of the south embankment has been excavated and remains open, apparently to facilitate the repair of a joint on the cinder pit sluice line (Photograph 5).

1. Ash Pond 1 - South Embankment Crest, Looking East

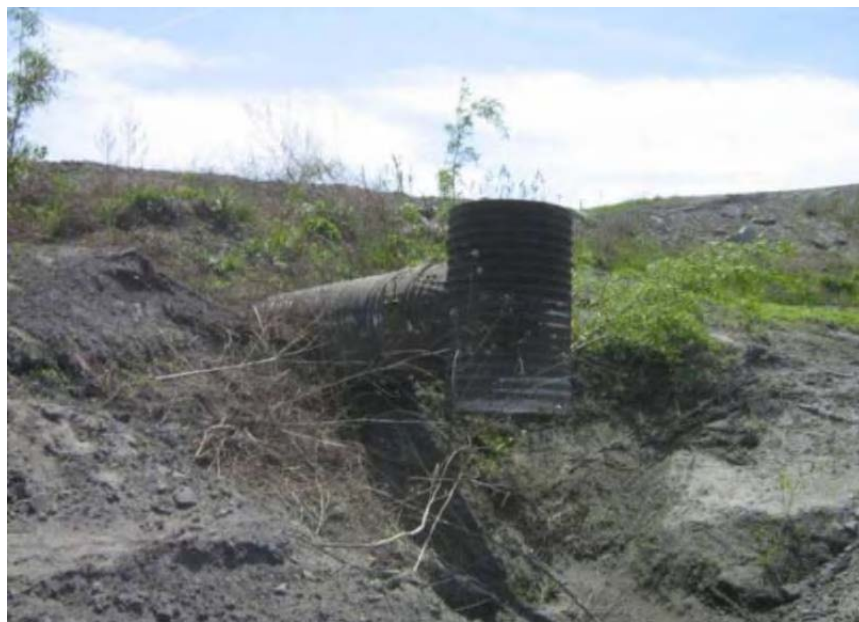
The outlet pipe in Ash Pond 1 appears to be in good condition. A 30-inch-diameter CMP tee is located at the southwestern end of the pond, connecting the pond with Ash Pond 2A (Photograph 2). No unusual movement was observed around the pipe penetration.

2. Ash Pond 1 - Inlet from Ash Pond 2A (30-inch-diameter CMP), Located at South Embankment Interior Slope

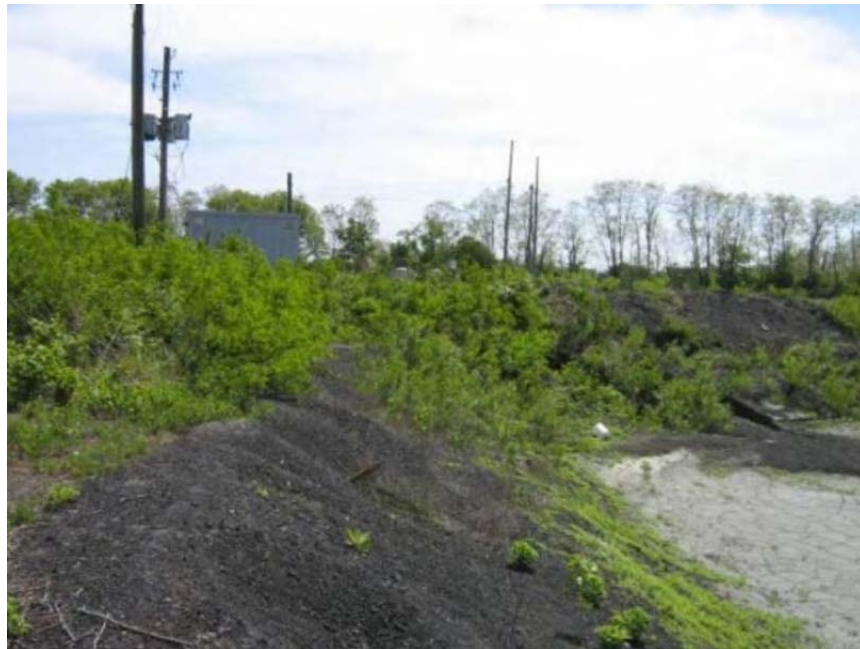
9. Ash Pond 1 - East Embankment Interior Slope, Looking South

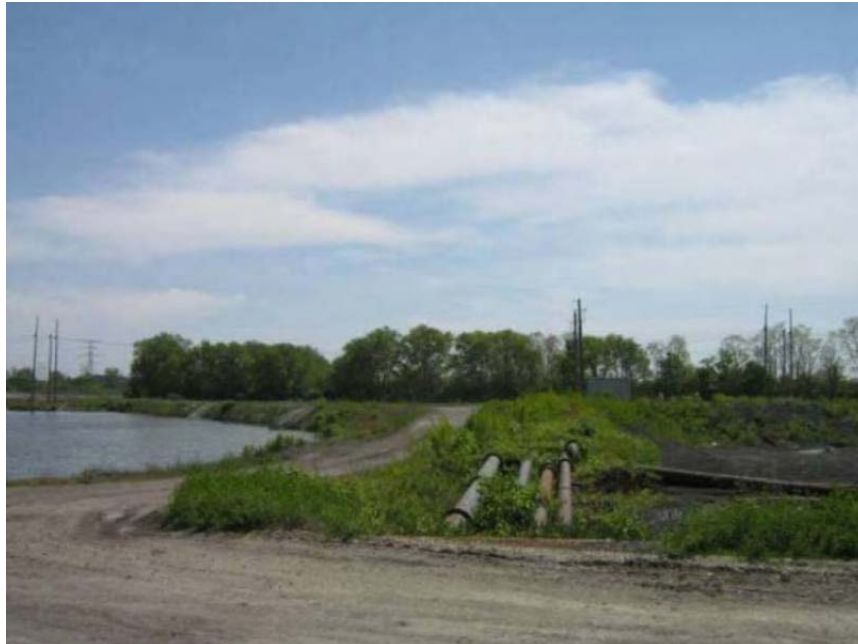
11. Ash Pond 1 - Four (4) 8-inch-Diameter Slice Lines along East Embankment Crest, Looking South

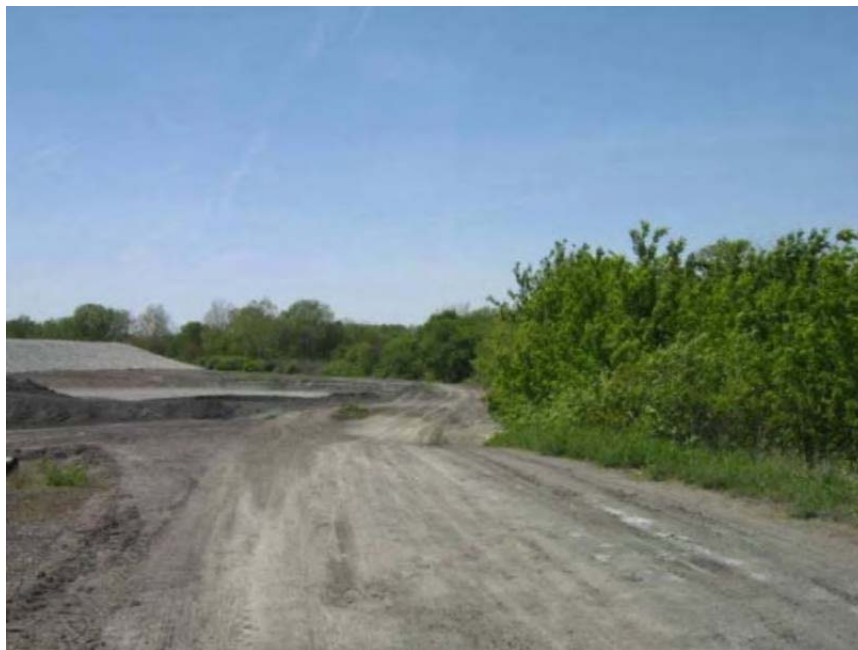
12. Ash Pond 1 - North Embankment Crest, Looking West, Depression Visible in Distance

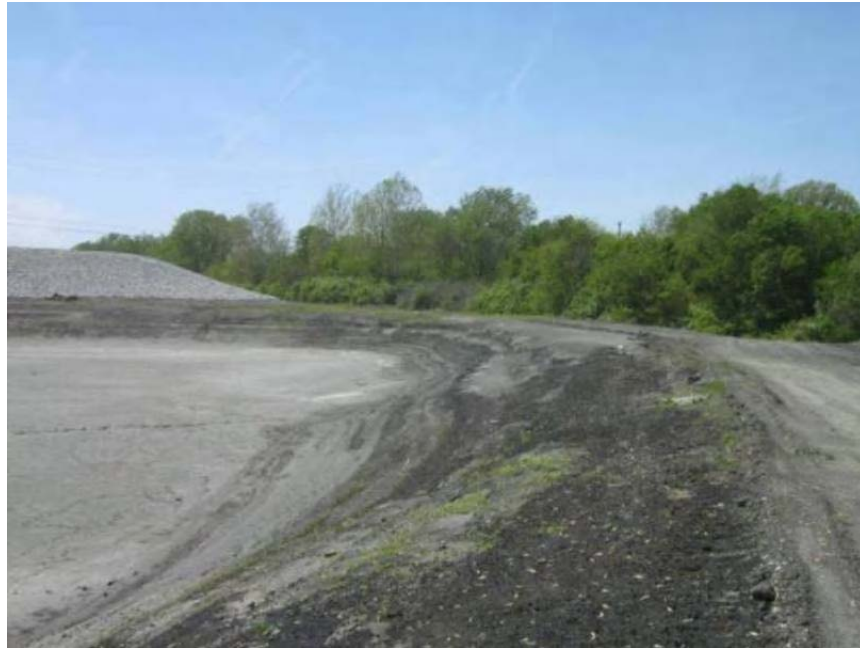
13. Ash Pond 1 - North Embankment Interior Slope, Looking West, Area of Beaching is Visible in Distance

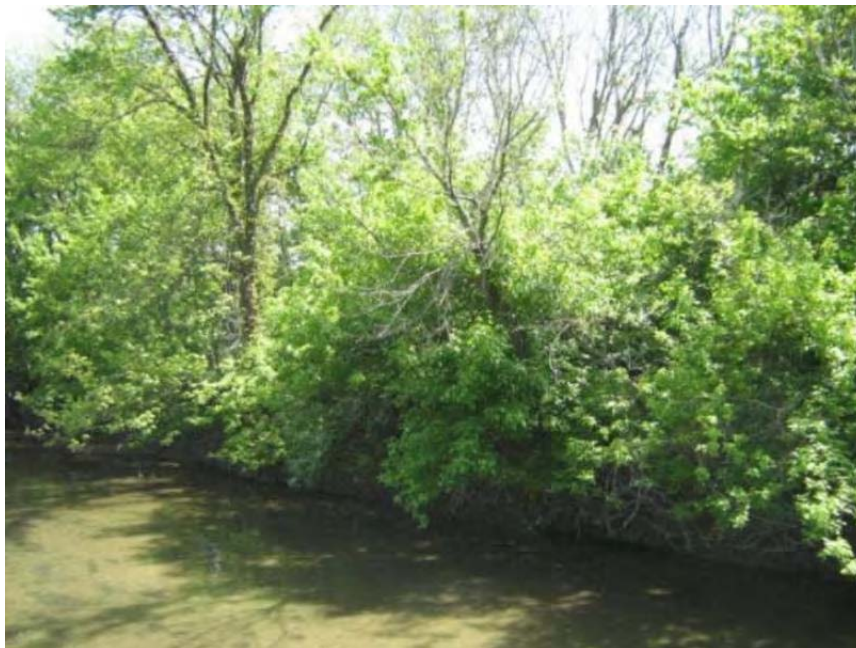
14. Ash Pond 1 - Dense Vegetation along North Embankment Exterior Slope, View from Bridge Over Lick Creek

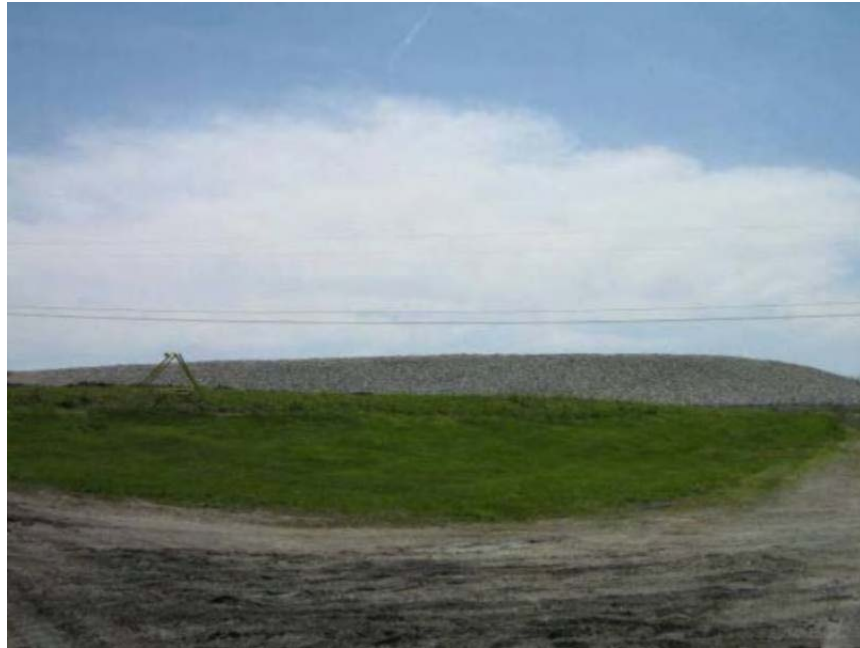
15. Ash Pond 1 - North Embankment Exterior Slope

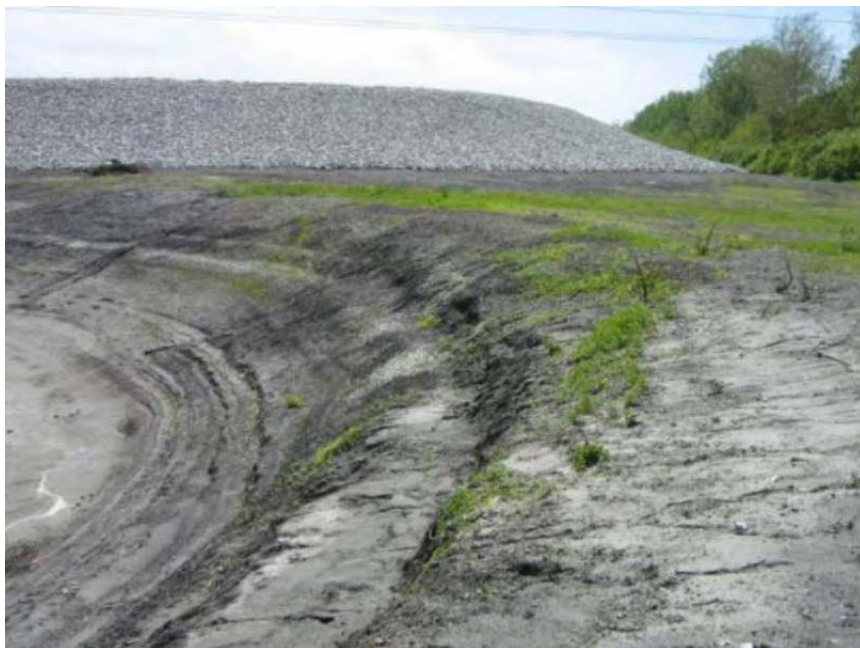
16. Ash Pond 1 - Beaching and Surface Erosion at the top of the North Embankment Interior Slope, Looking West

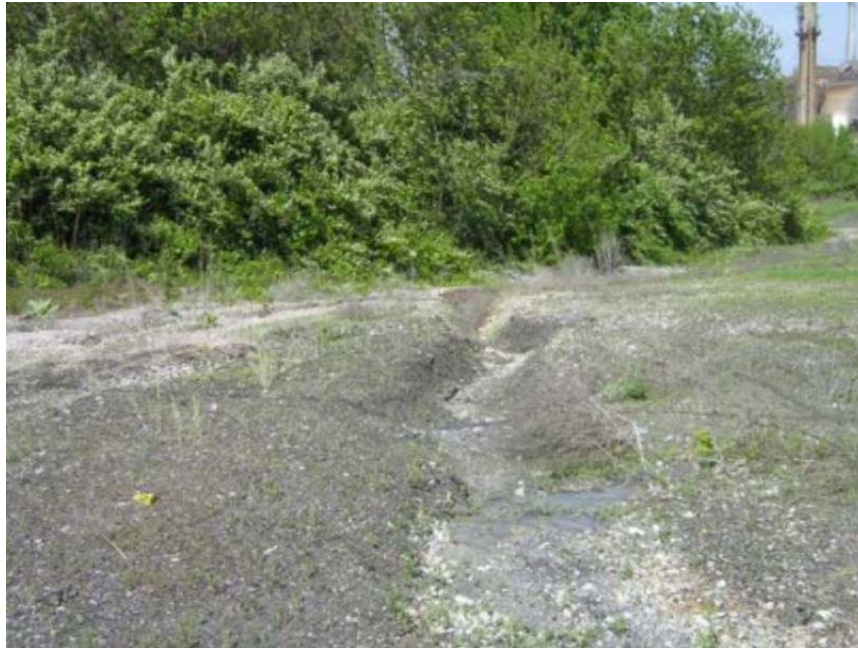
17. Ash Pond 1 - Erosion Rill West of the North Embankment

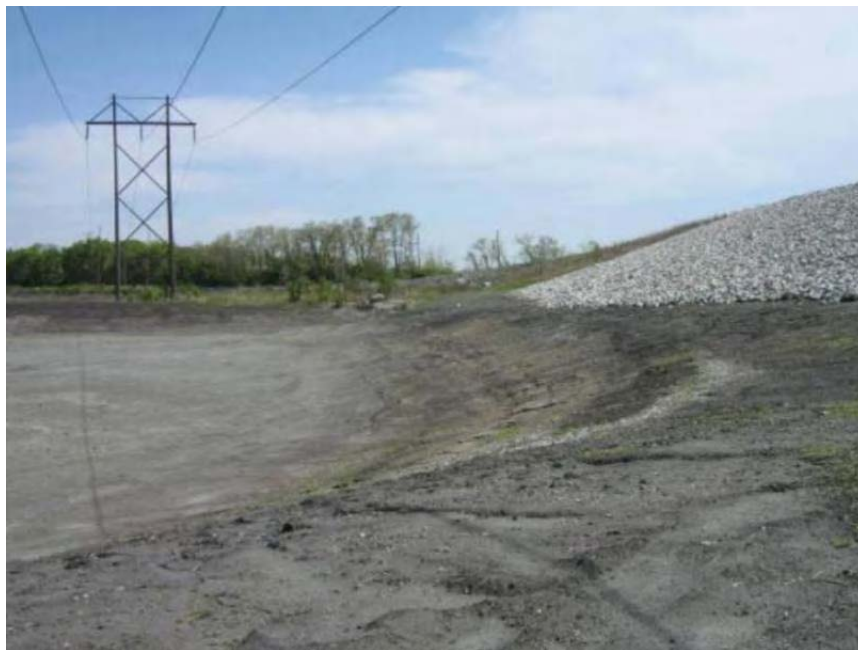
18. Ash Pond 1 - West Embankment Interior Slope, Looking South

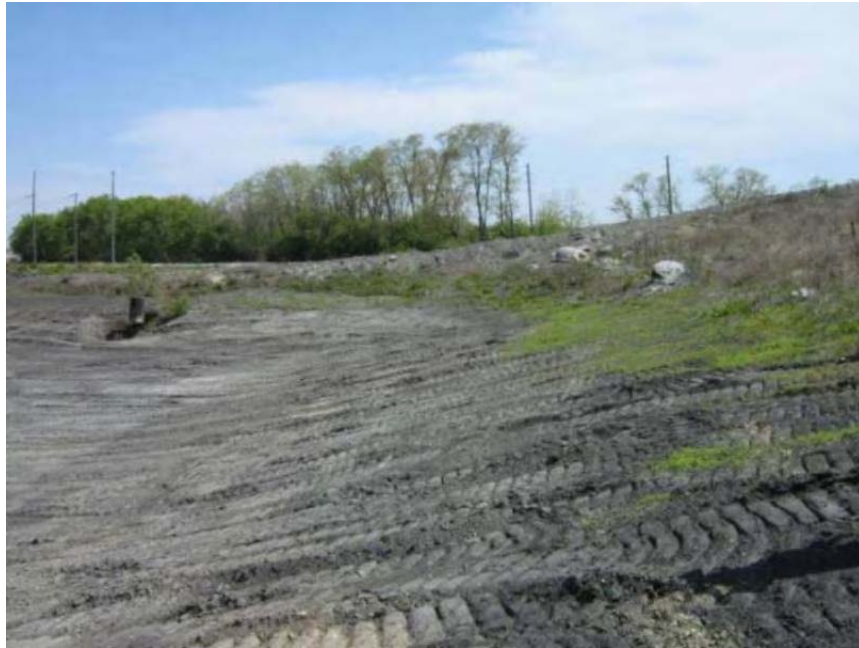
19. Ash Pond 1 - Scarified Surface of West Embankment Interior Slope, Looking South

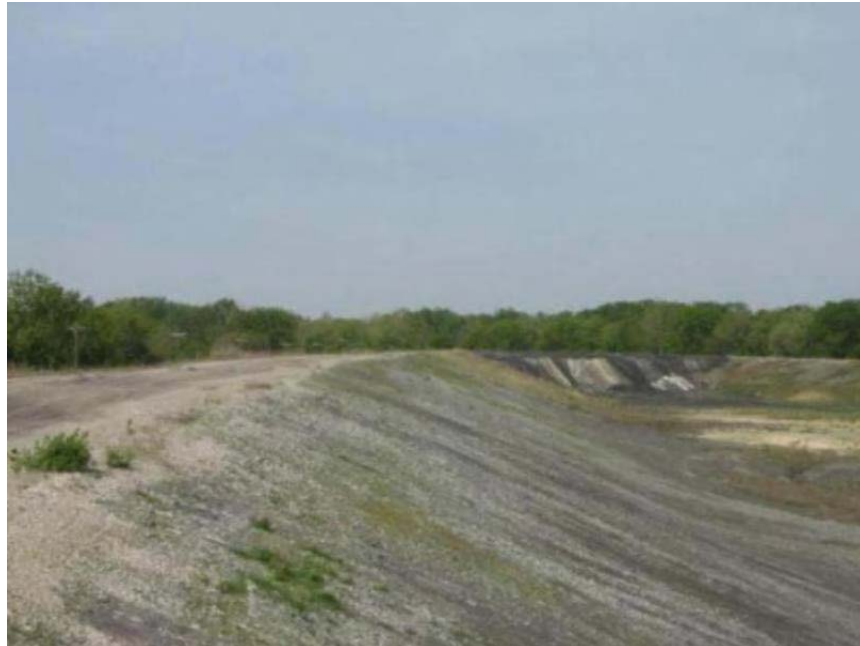
20. Ash Pond 2 - South Embankment Interior Slope, Looking West,
Sparse Vegetation and Erosion Rills are Visible

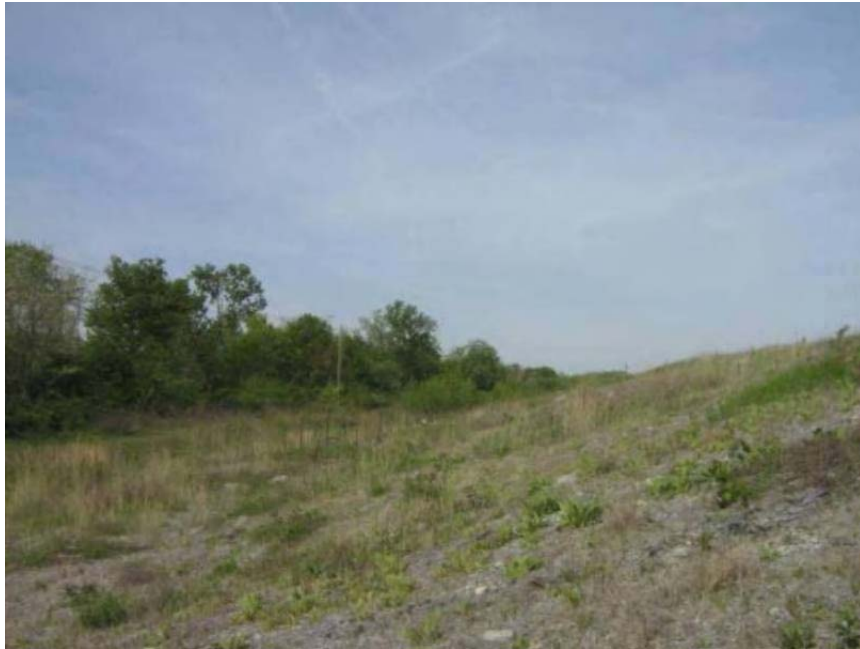
22. Ash Pond 2 - South Embankment Exterior Slope, Looking West

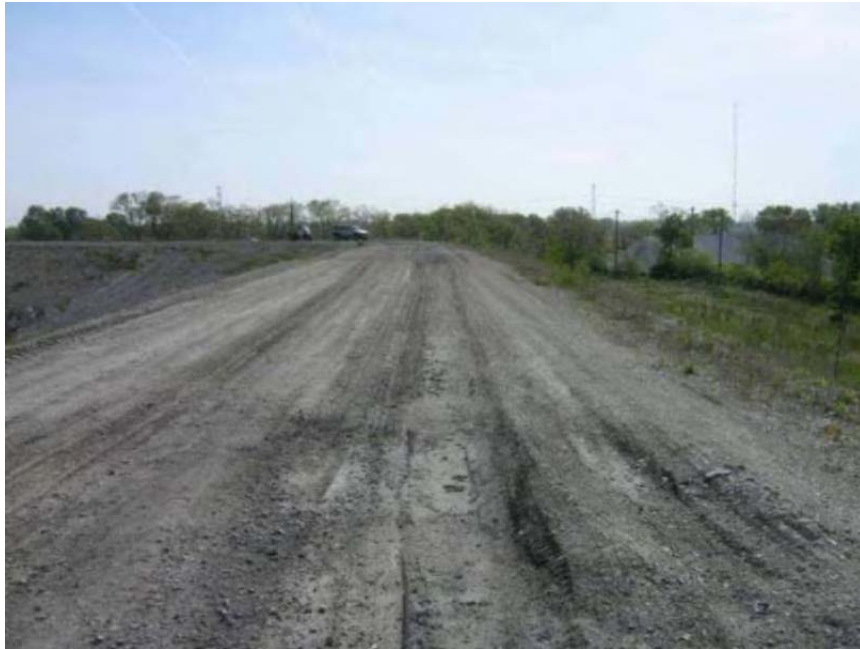
24. Ash Pond 2 - Ruts along South Embankment Crest, Looking East

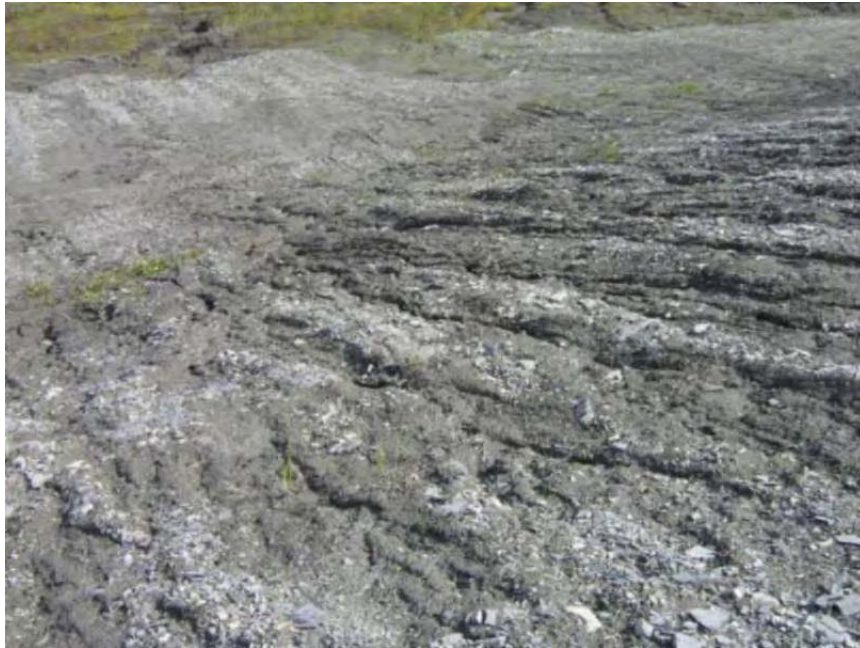
26. Ash Pond 2 - Erosion Rills on South Embankment Interior Slope

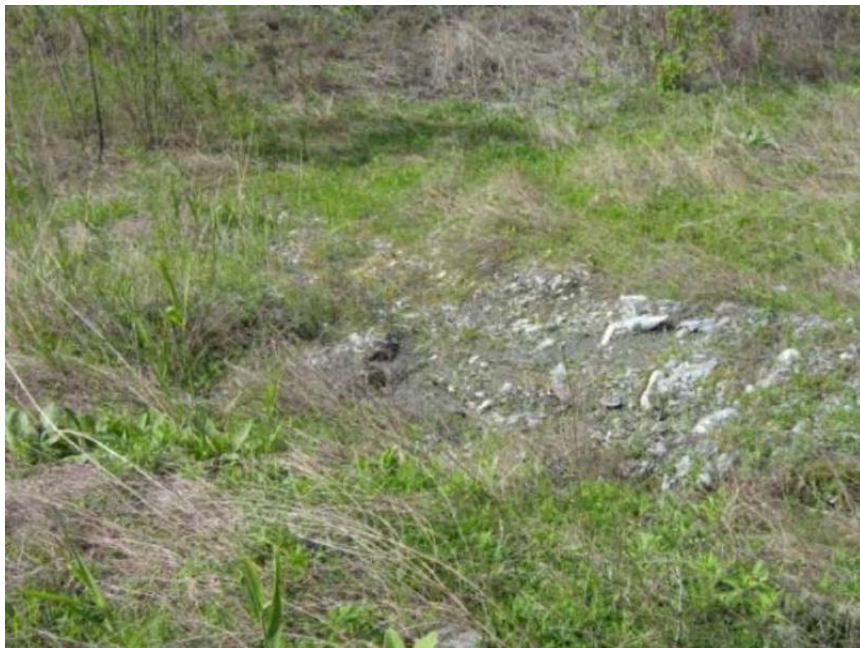
27. Ash Pond 2 - Surface Erosion along South Embankment Exterior Slope (Approximately 8' Width, 4' Deep, 30' Long)

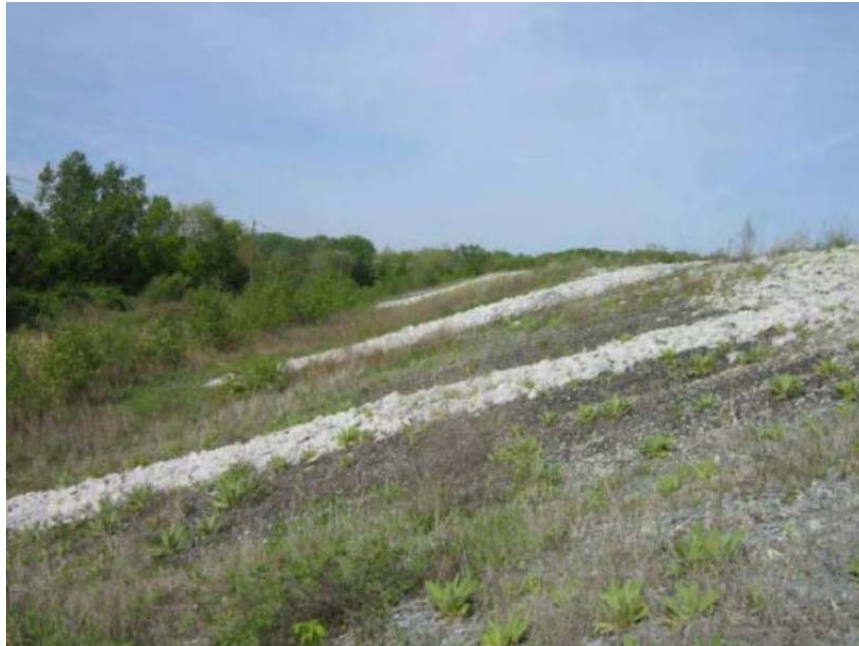
28. Ash Pond 2 - Riprap used to fill in Erosion Rills, South Embankment Exterior Slope, Looking West

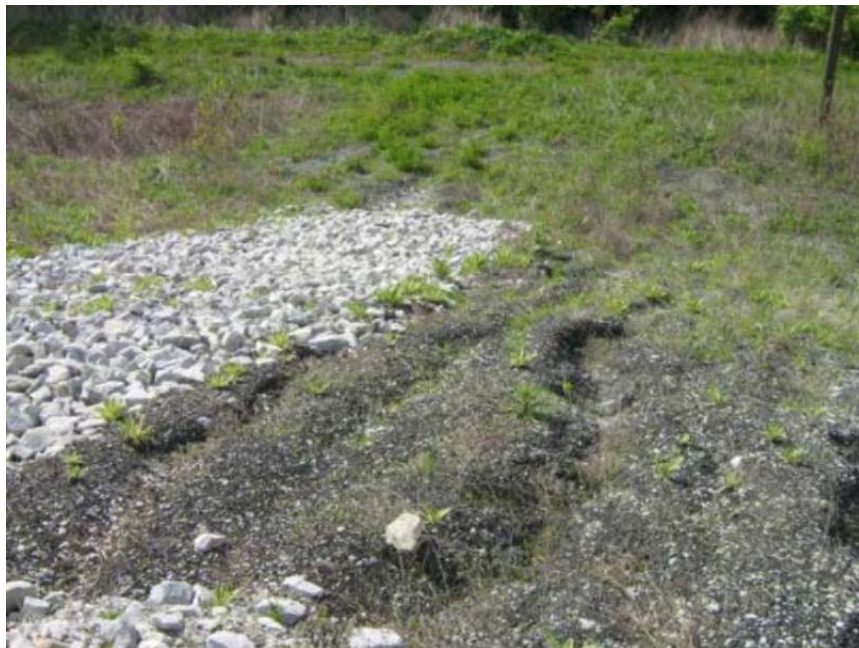
29. Ash Pond 2 - Erosion Rills Adjacent to Riprap on South Embankment Exterior Slope

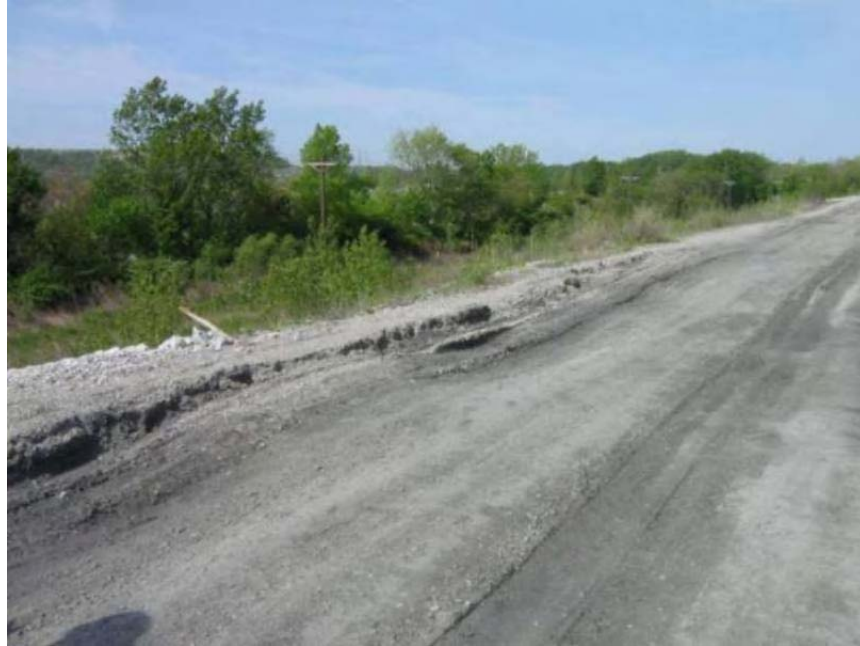
30. Ash Pond 2 - Ruts along South Embankment Crest

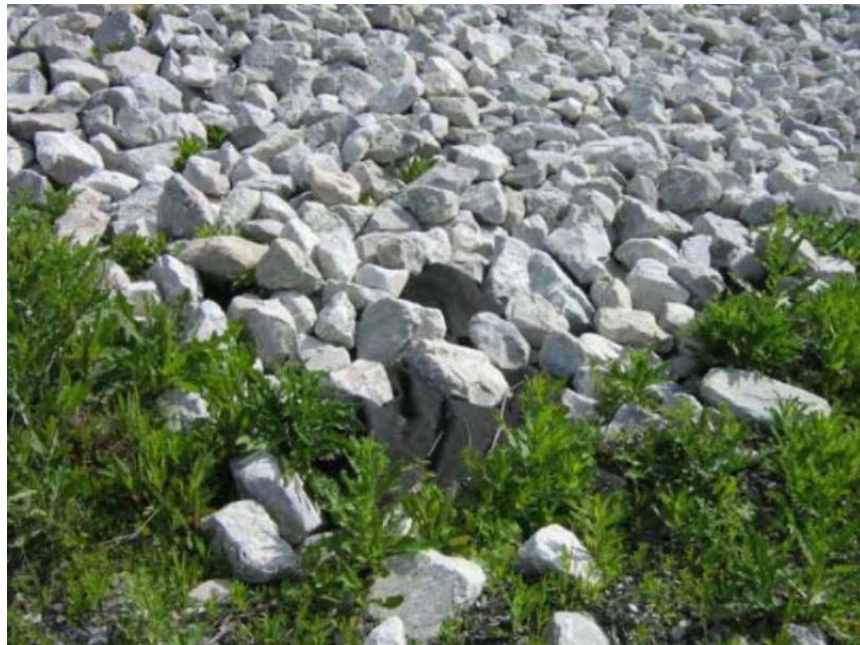
31. Ash Pond 2 - Filter Fabric under Riprap Layer. Filter Fabric is used when Erosion Rill Extended to Crest

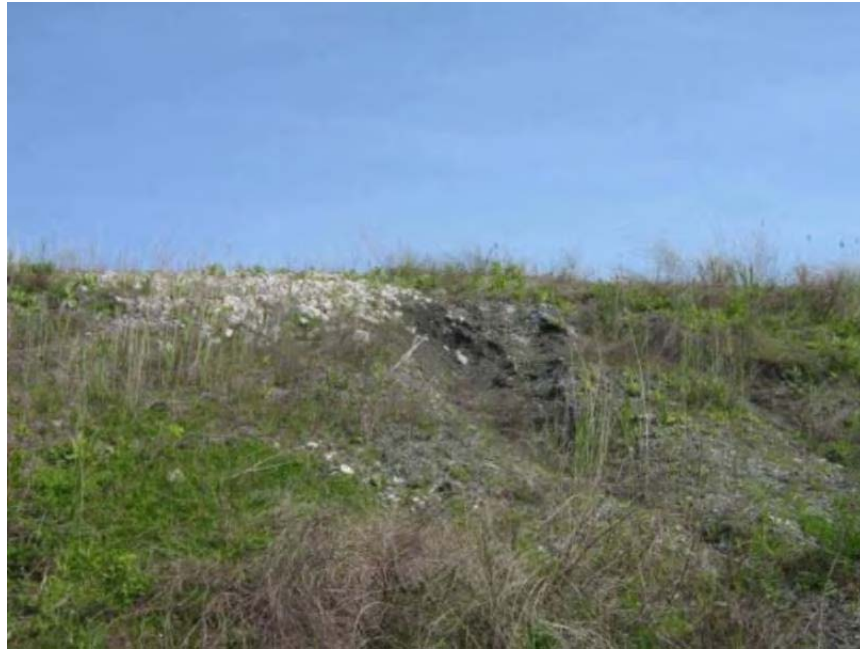
32. Ash Pond 2 - Surface Erosion below Riprap along South Embankment Exterior Slope

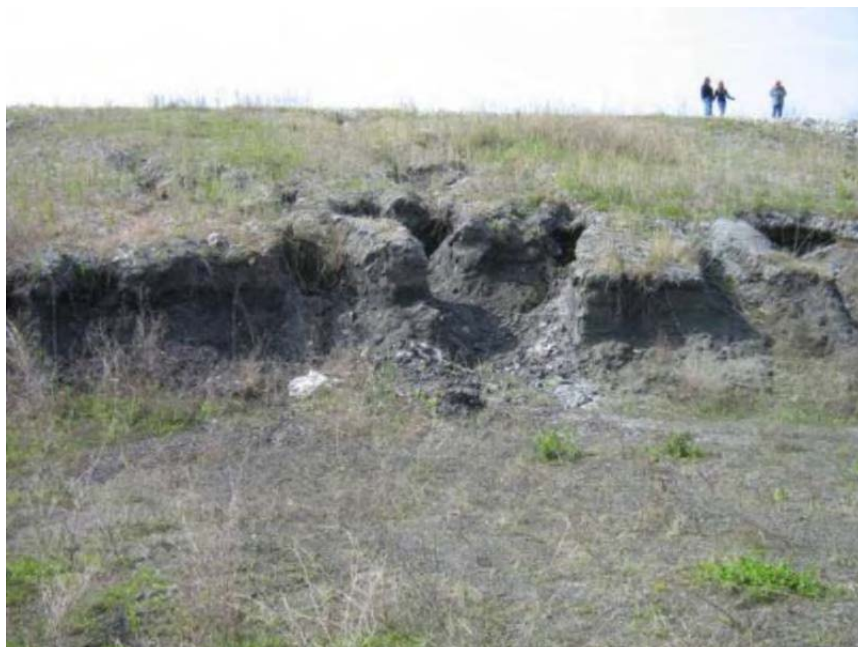
34. Ash Pond 2 - Erosion Rills and Undercutting of South Embankment Interior Slope, Looking South from Basin Floor

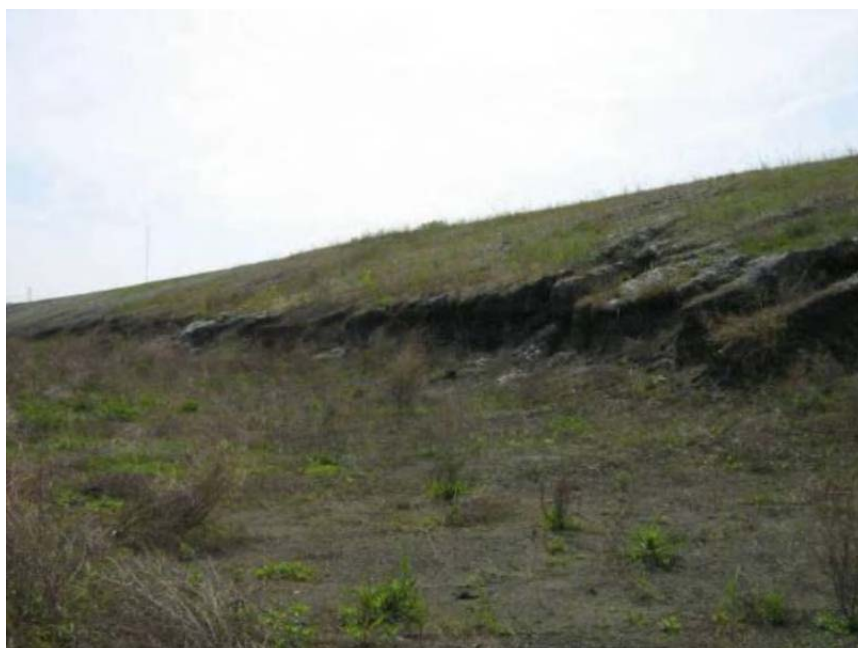
35. Ash Pond 2 - Erosion Rills and Slides on South Embankment Interior Slope, Looking East from Basin Floor

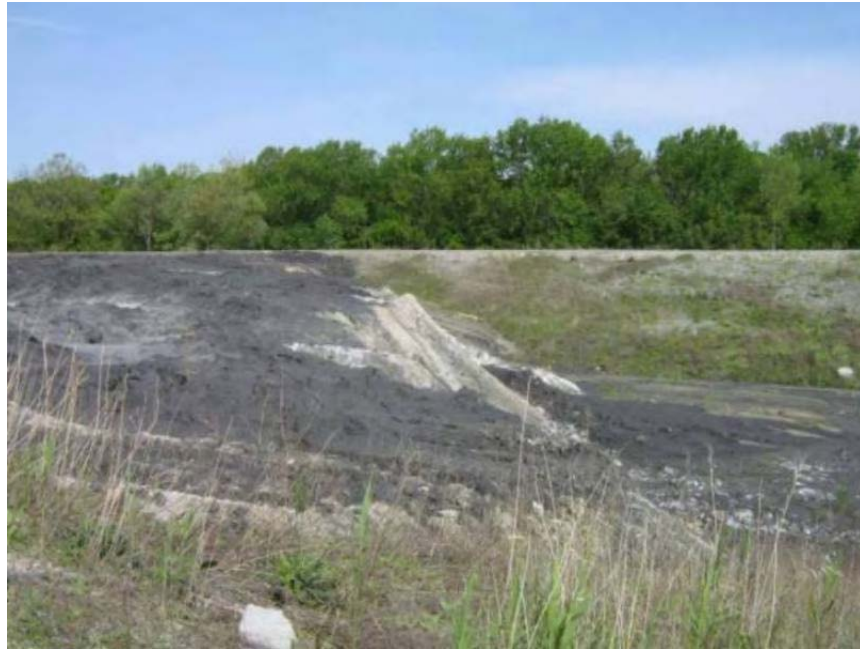
36. Ash Pond 2 - Dredging Spoil, West Embankment Interior Slope,
Looking North

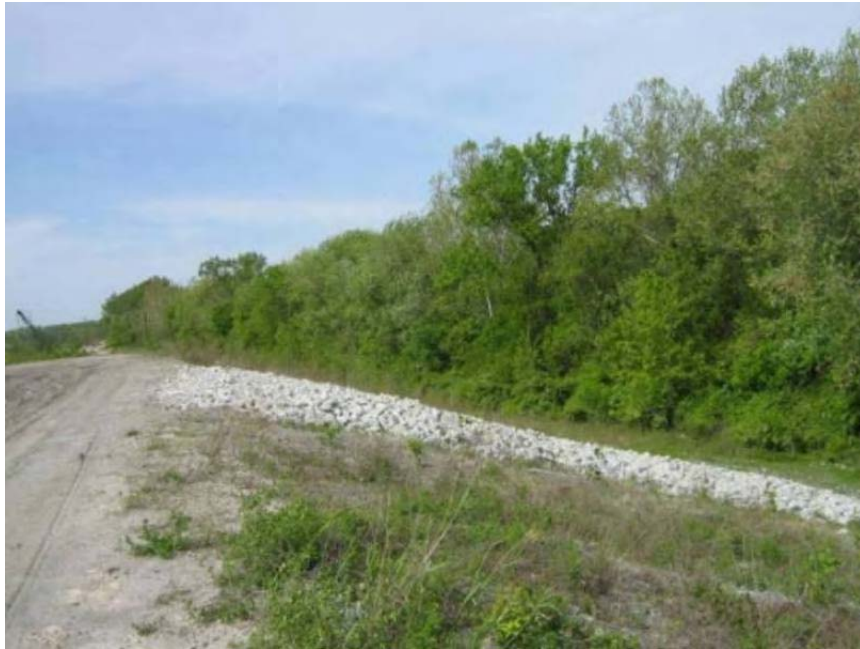
38. Ash Pond 2 - Northwest Embankment Exterior Slope, Looking West

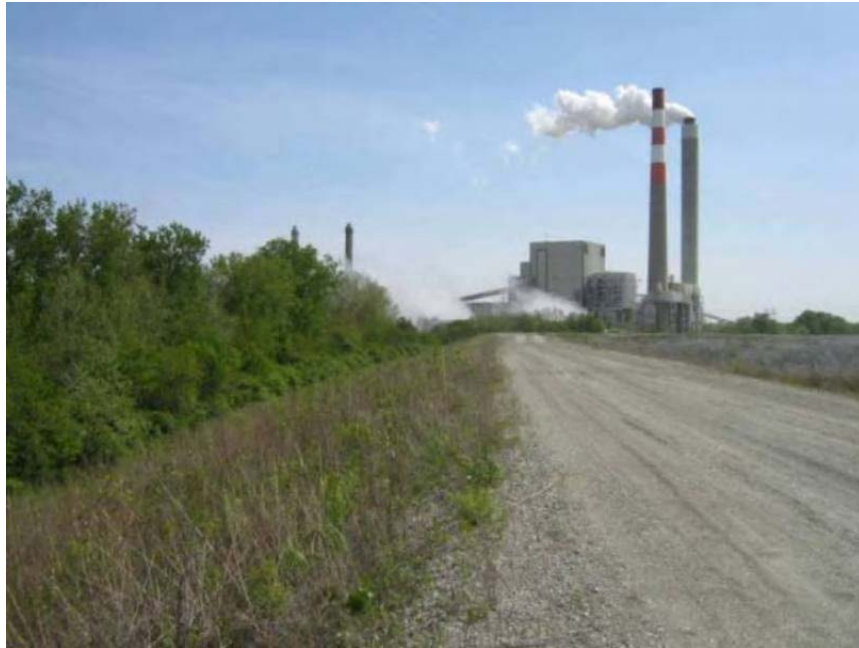
40. Ash Pond 2 - North Embankment Crest, Looking East,
Established Vegetation on Exterior Slope

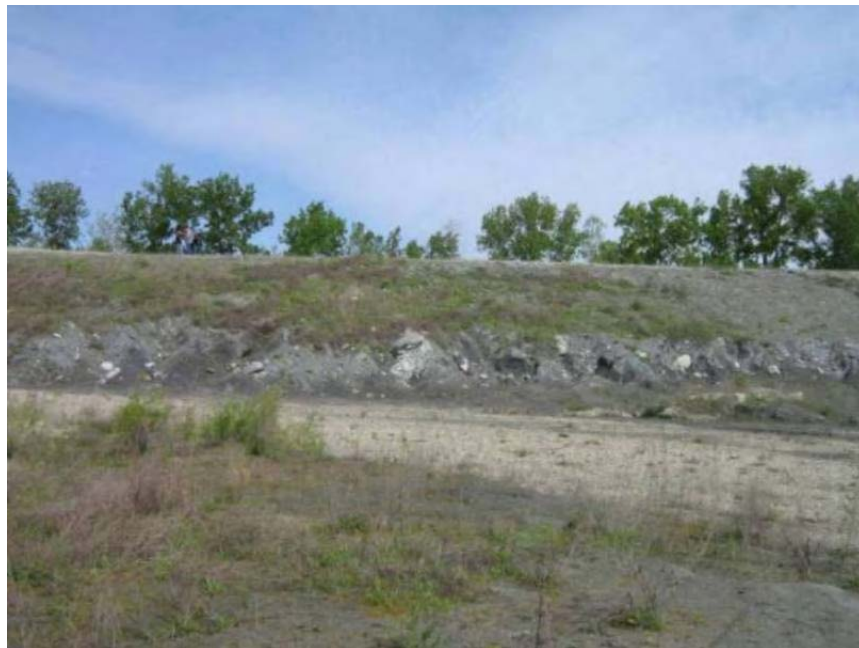
41. Ash Pond 2 - North Embankment Interior Slope, Looking North
from Basin Floor

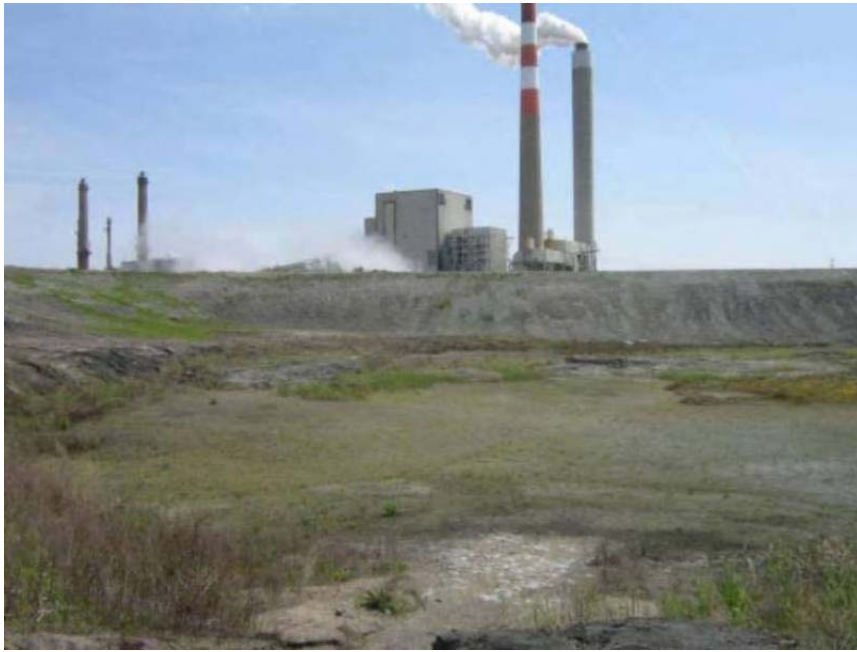
42. Ash Pond 2 - East Embankment Interior Slope, View from Basin Floor

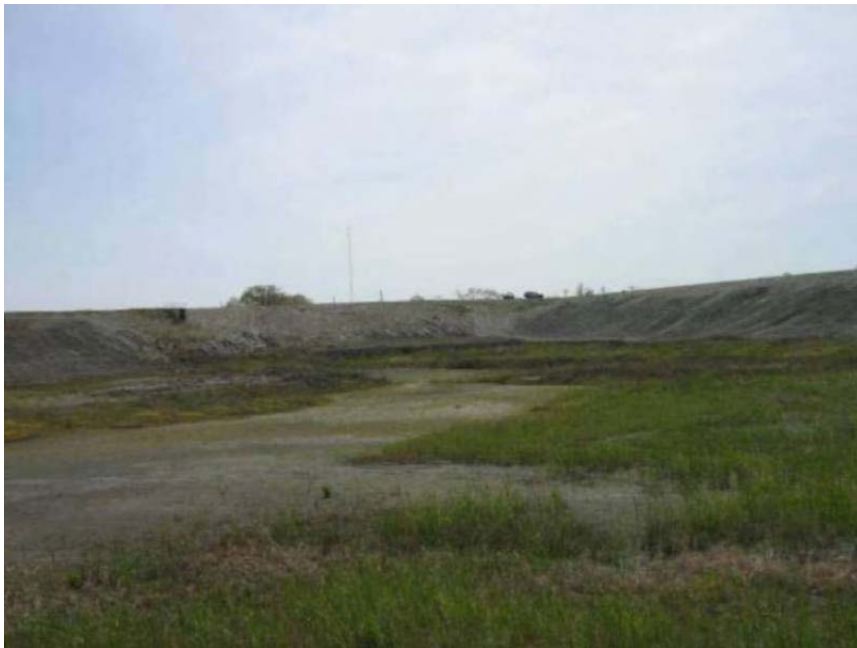
43. Ash Pond 2 - East Embankment Interior Slope, View from Basin

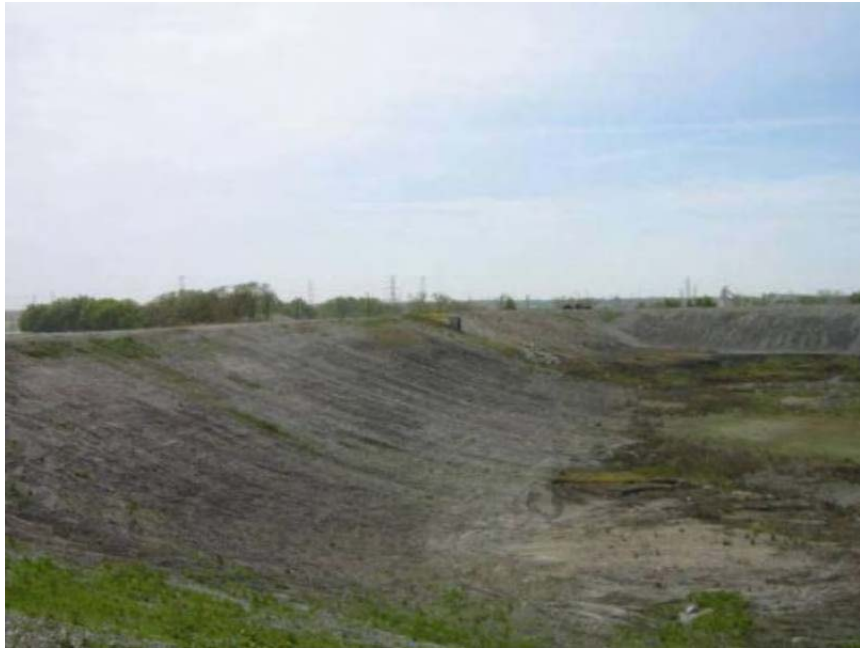
44. Ash Pond 2 - East Embankment Interior Slope, Looking South

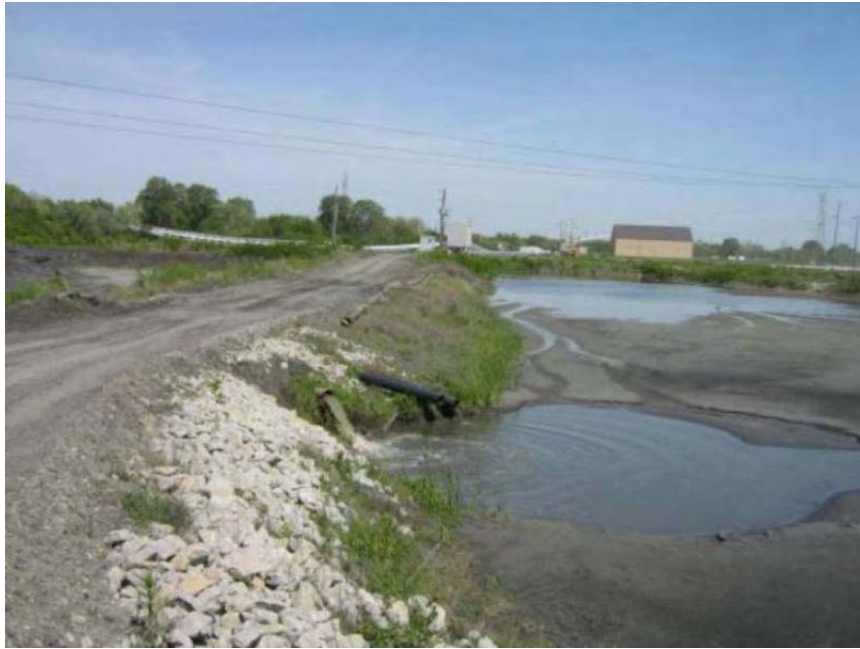
46. Ash Pond 2A - North Embankment Interior Slope, Looking East,
Three (3) 8-inch-Diameter Outfall Pipes

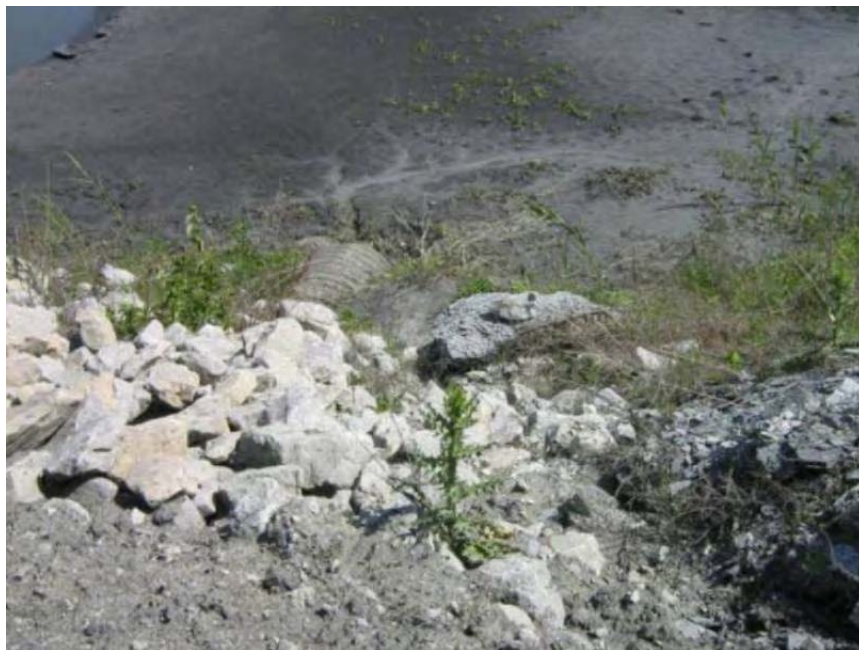
47. Ash Pond 2A - North Embankment Interior Slope, Riprap above
30-inch-Diameter Outlet and Erosion Rill on the Right

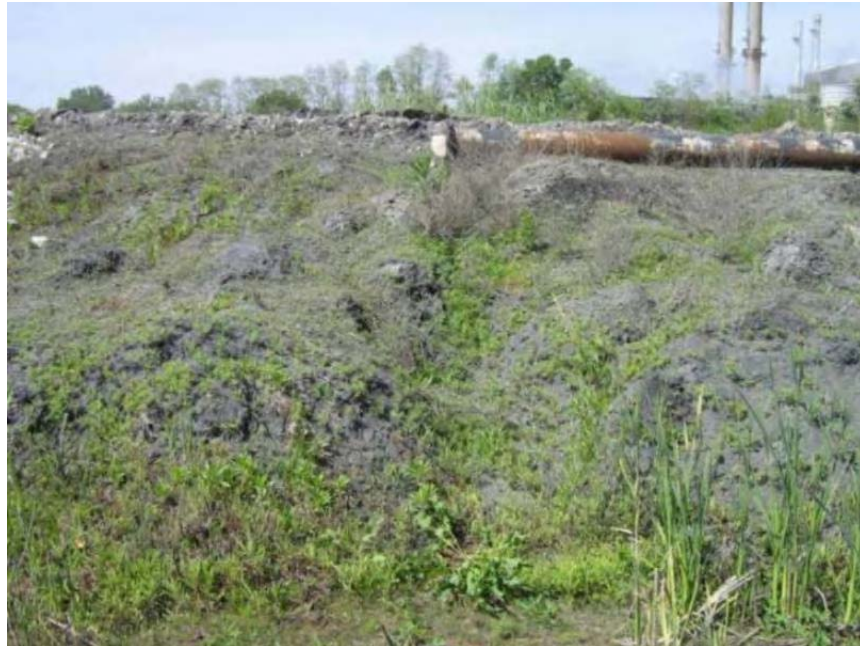
48. Ash Pond 2A - Erosion Rill along North Embankment Interior Slope, View from Pond (Approximately 1' Wide, 10' Long)

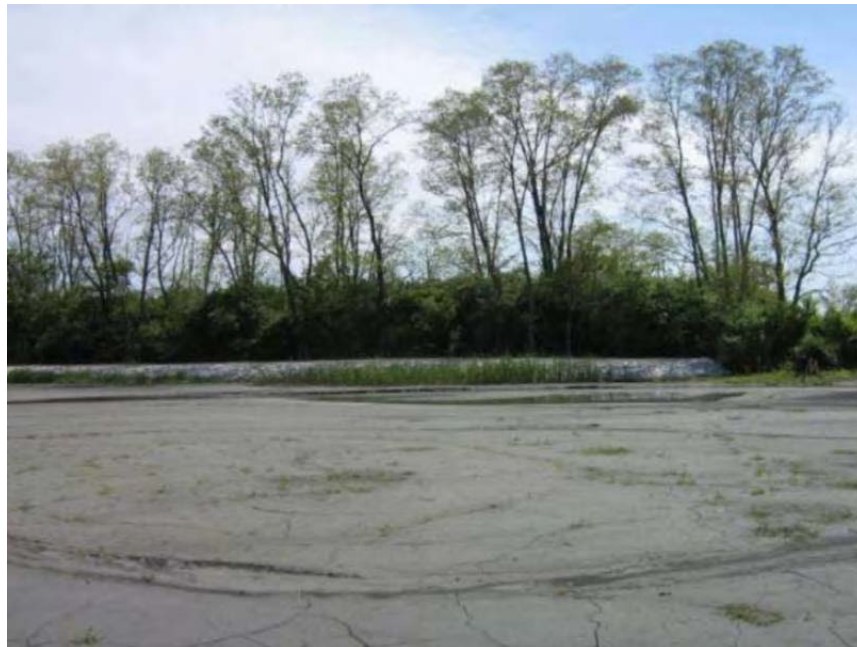
50. Ash Pond 2A - Vegetation along South Embankment Interior Slope, Looking South

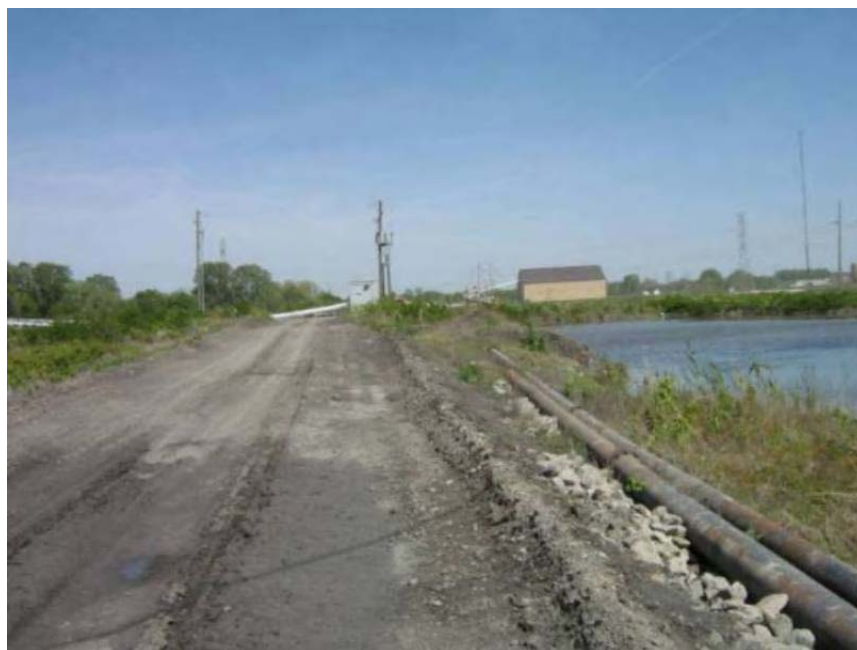
51. Ash Pond 2A - North Embankment Crest, Looking East

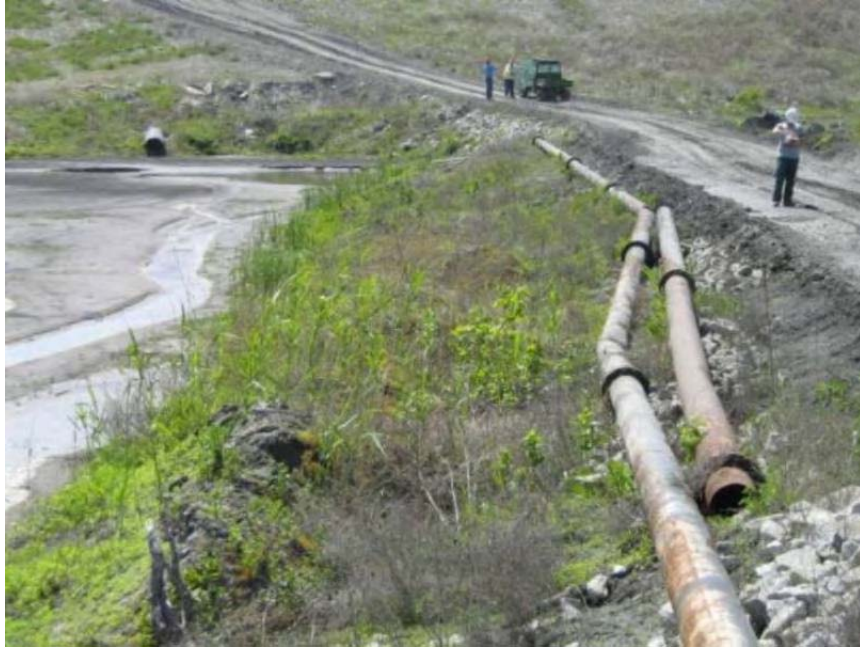
52. Ash Pond 2A - North Embankment Interior Slope, Looking West

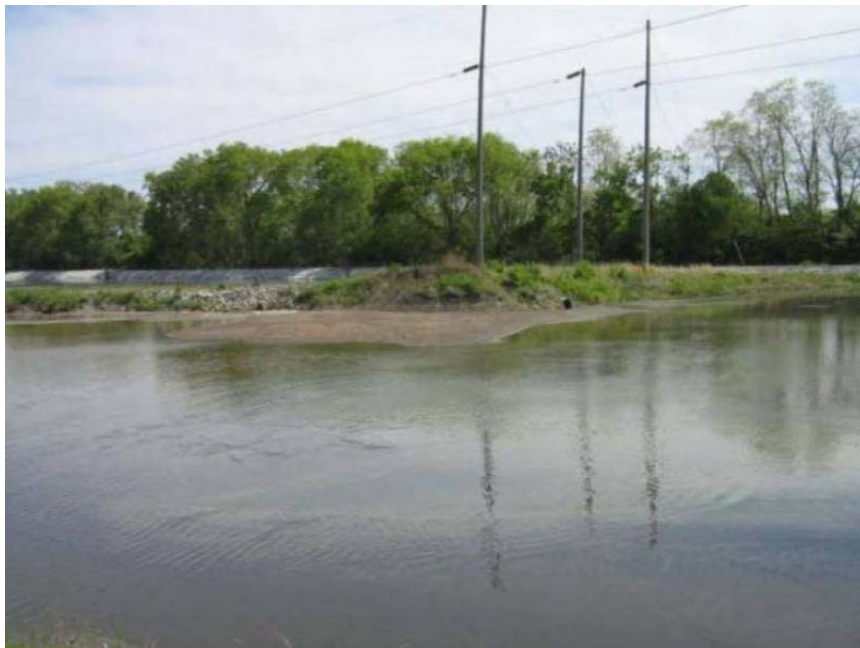
53. Ash Pond 2A - South Embankment Interior Slope, Looking South

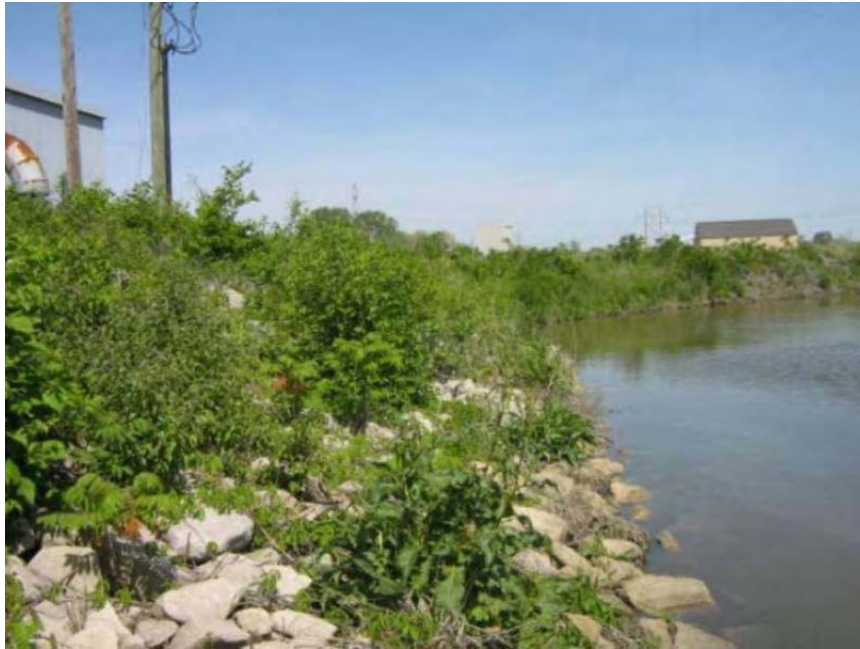
54. Ash Pond 2A - North Embankment Interior Slope, Looking East,
Riprap Erosion at Waterline

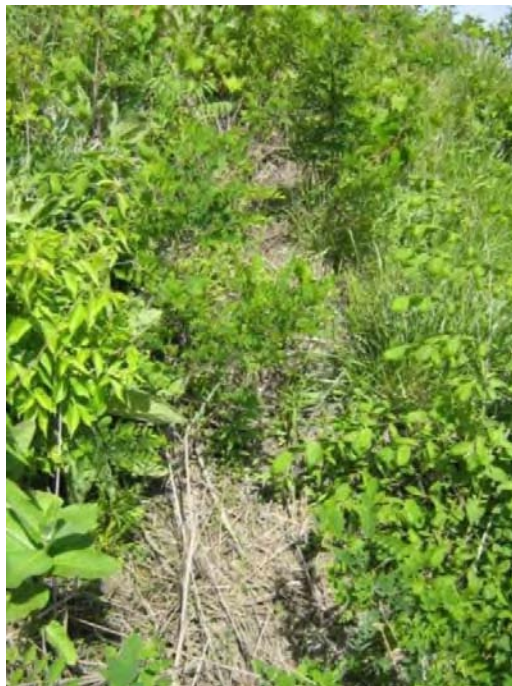
55. Ash Pond 2A - Vegetation and Erosion on North Embankment
